TECHNICAL NOTE 3269

ADDITIONAL STATIC AND FATIGUE TESTS OF HIGH-STRENGTH
ALUMINUM-ALLOY BOLTED JOINTS

By E. C. Hartmann, Marshall Holt, and I. D. Eaton

Aluminum Company of America

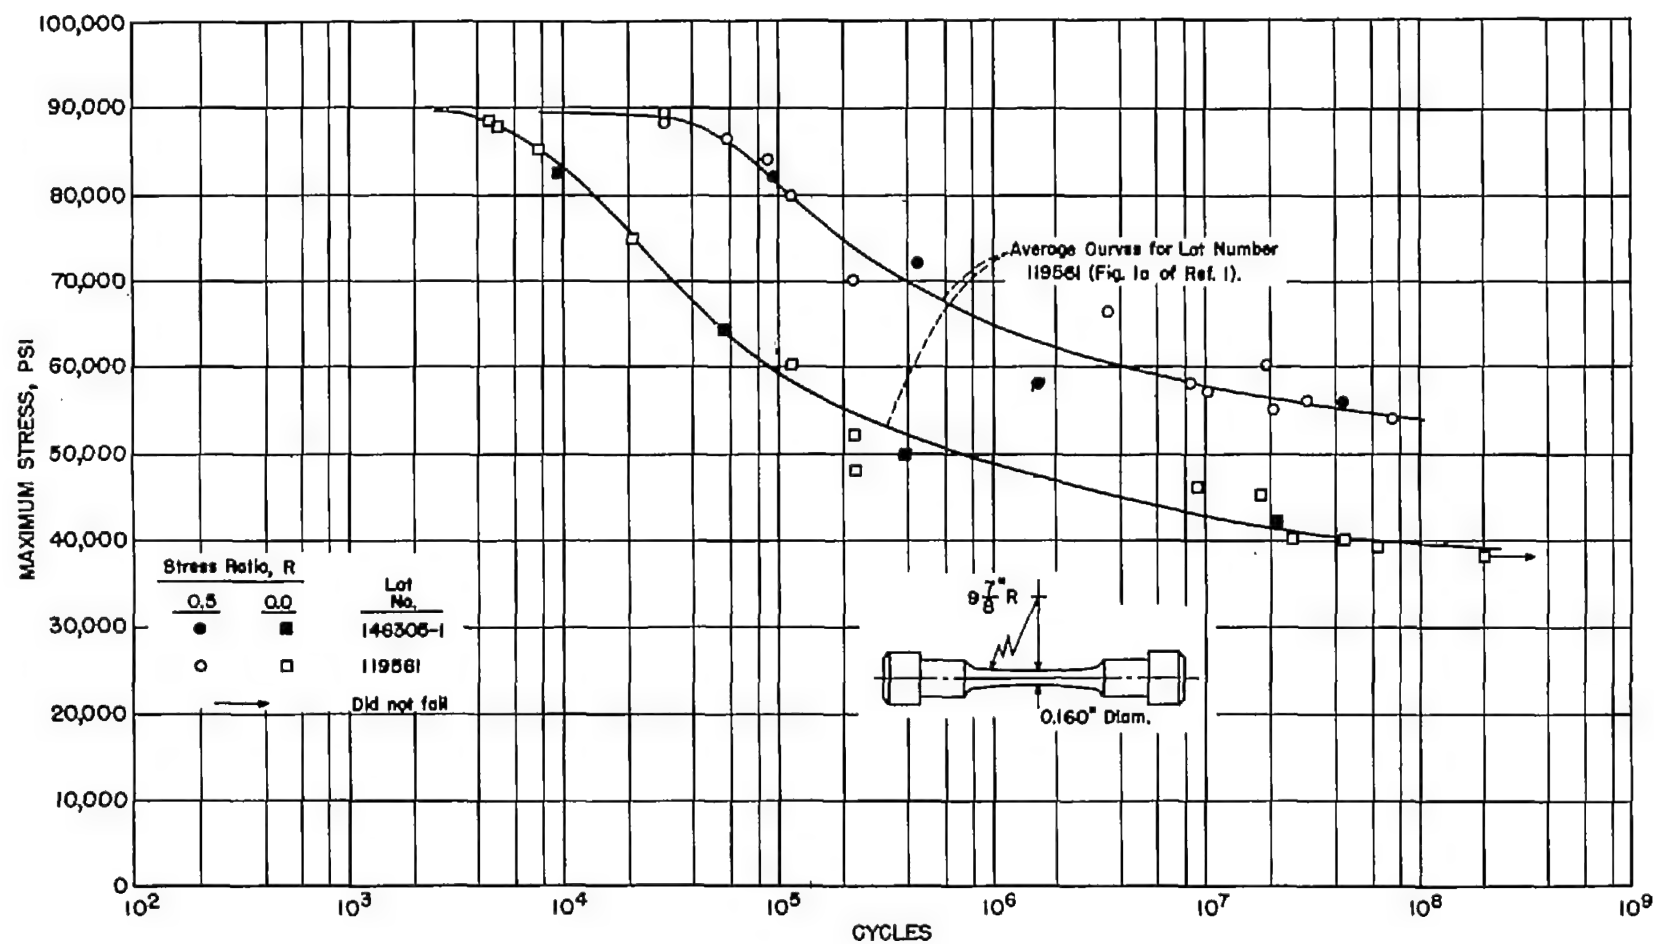
Figure 1.- Direct tension-compression fatigue data for 75S-T6 extruded bar
 (1 ¹/₄ by 4 inches).

Direct-stress fatigue tests were made on polished round specimens as described in reference 1 to determine the degree of agreement of basic fatigue strengths for the old and new lots of 75S-T6 and 24S-T4 aluminum alloys. The fatigue test results for the two lots of each alloy are plotted in figures 1 and 2 where it is seen that the direct-stress fatigue strengths for the two lots of 75S-T6 compare very well and that the fatigue strengths of the new lot of 24S-T4 are slightly higher than the results obtained on the original lot, but such small differences are not considered significant in light of the data in reference 3.

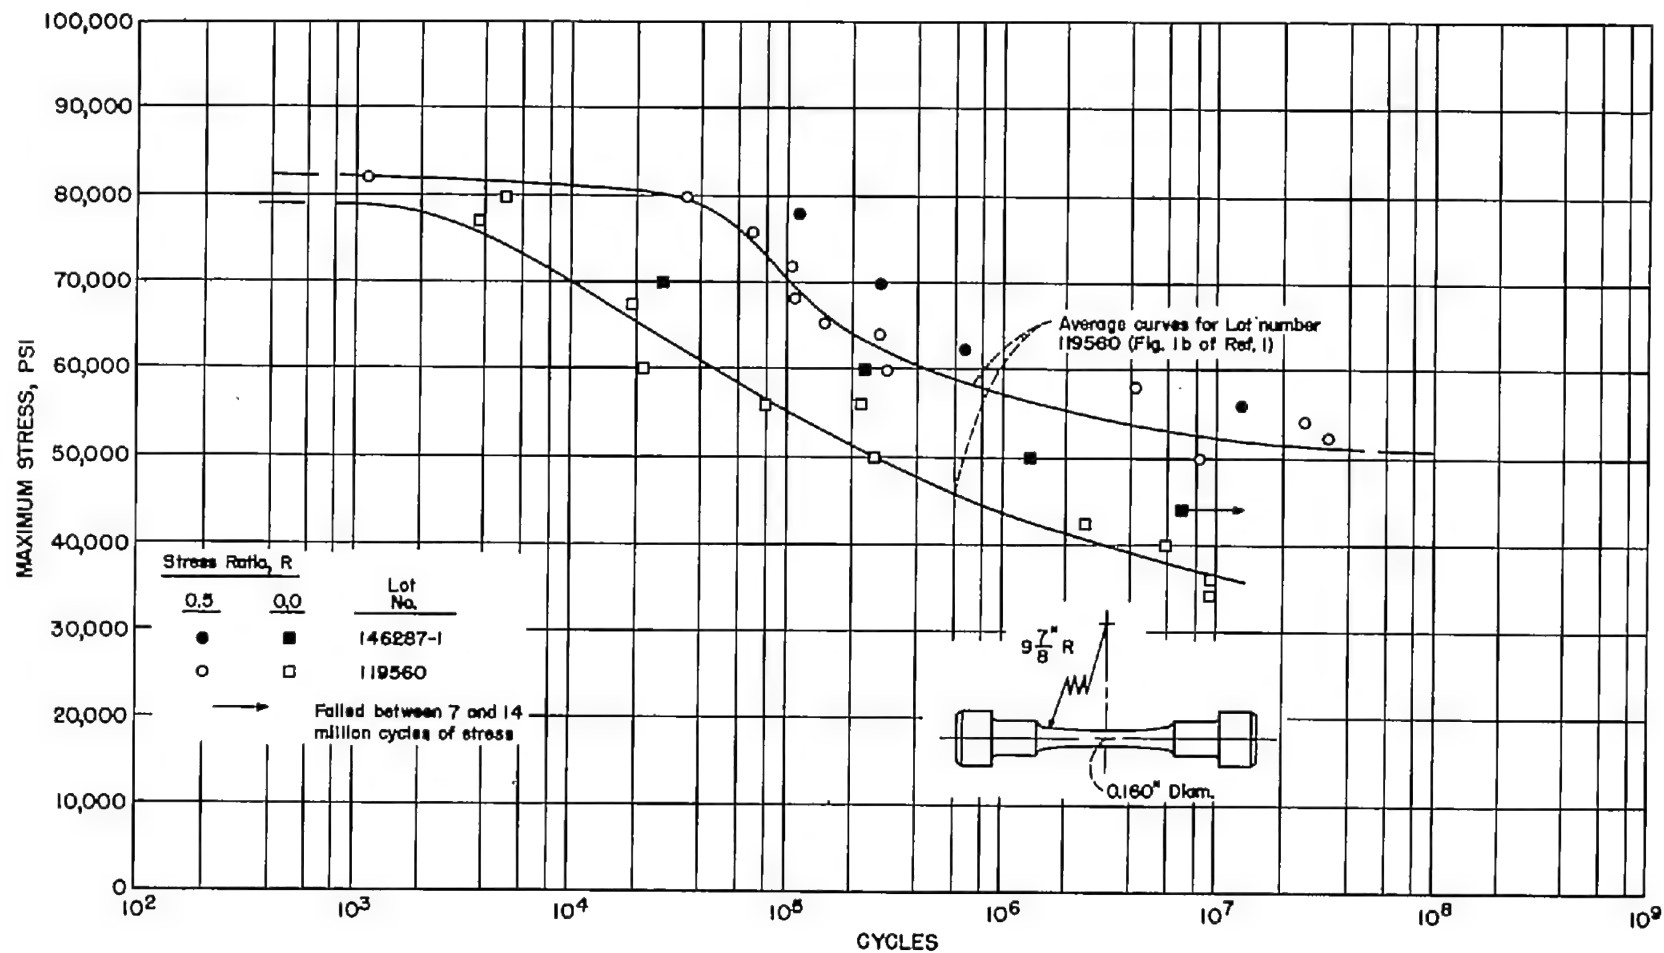
Figure 2.- Direct tension-compression fatigue data for 248-T4 extruded bar ($\frac{1}{4}$ by 4 inches).

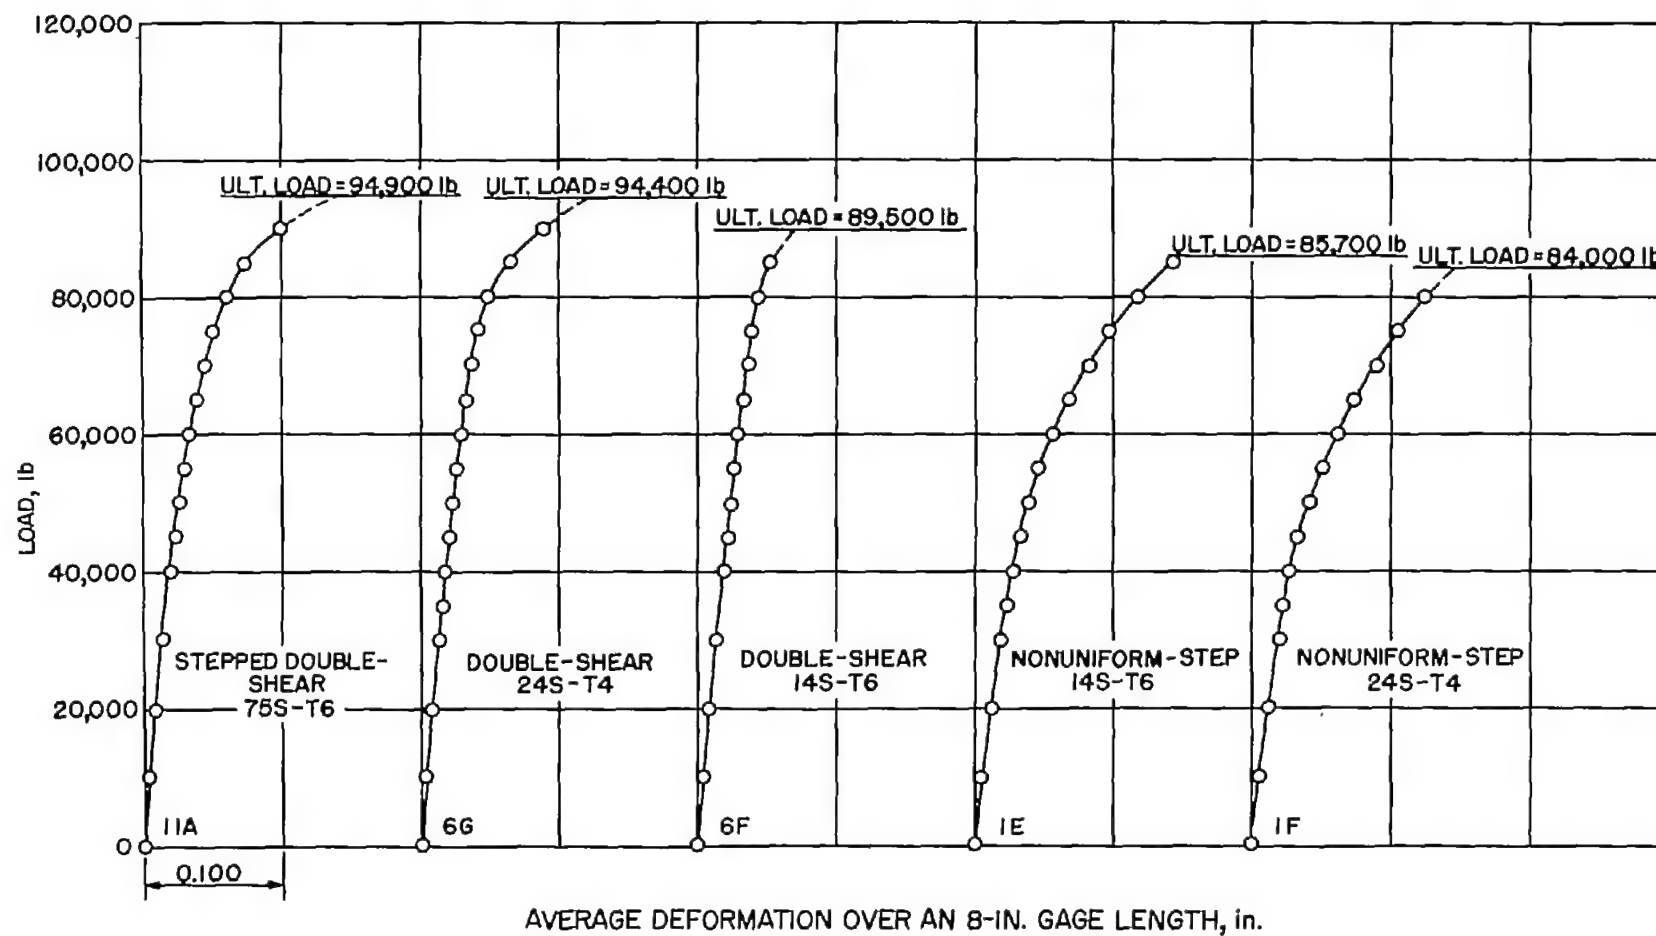
Figure 4.- Curves of static tensile load against deformation for high-strength aluminum-alloy bolted joints.

The results of the additional static tests are presented in figure 4 and are summarized in table II, together with the results for the 75S-T6 nonuniform-step and double-shear joints taken from table IV of reference 1.

The stepped double-shear joint, the new joint design tested in this investigation, withstood an ultimate load of 94,900 pounds, in other words, 29,200 pounds per pound of joint weight. The deformation in an 8-inch gage length under a load of 16,000 pounds was 0.0060 inch. When compared with the static test results of the other 75S-T6 aluminum-alloy joints given in reference 1, it is found that the ultimate load of the stepped double-shear joint is lower than that of the double-shear (115,250 pounds), the uniform-step (107,800 pounds), the plain-scarf (107,250 pounds), and the nonuniform-step (100,000 pounds) joints. The ultimate load of the new stepped double-shear joint exceeds the ultimate loads of the bolted-keyed, double-scarf, single-shear, serrated, and clamped-keyed joints. The load per pound of weight and deformation in 8 inches at 16,000-pound load are also intermediate to the values obtained for the other types of 75S-T6 joints.

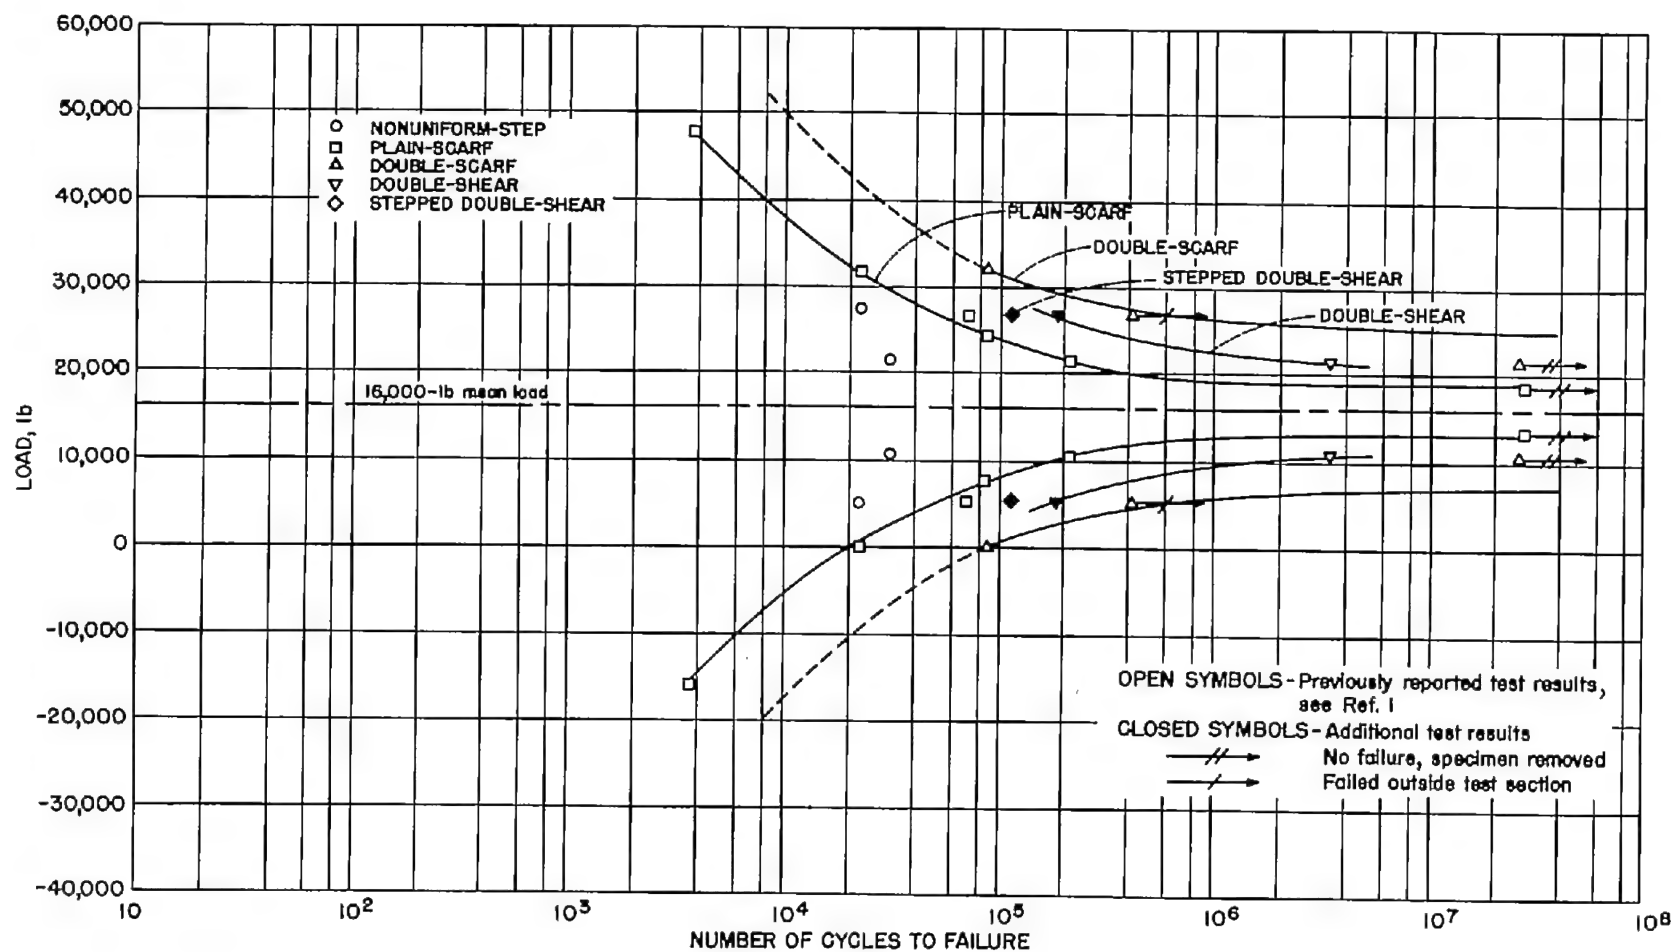
Figure 6.- Direct-stress fatigue curves for 75S-T6 aluminum-alloy bolted joints. Mean load, 16,000 pounds.

The result of the fatigue test on the stepped double-shear joint is included in table IV and is plotted with other results from this and the initial part of the investigation in figure 6. It can be seen that, of the 75S-T6 joints tested, the fatigue life of the stepped double-shear joint (111,400 cycles) is exceeded by that of the double-scarf (418,000 cycles) and double-shear (187,400 cycles) joints. The fatigue fracture shown in figure 7 occurred at the bolt holes in the thin portion of the tongue. No additional fractures were found, either in the tongue or in the outside members.

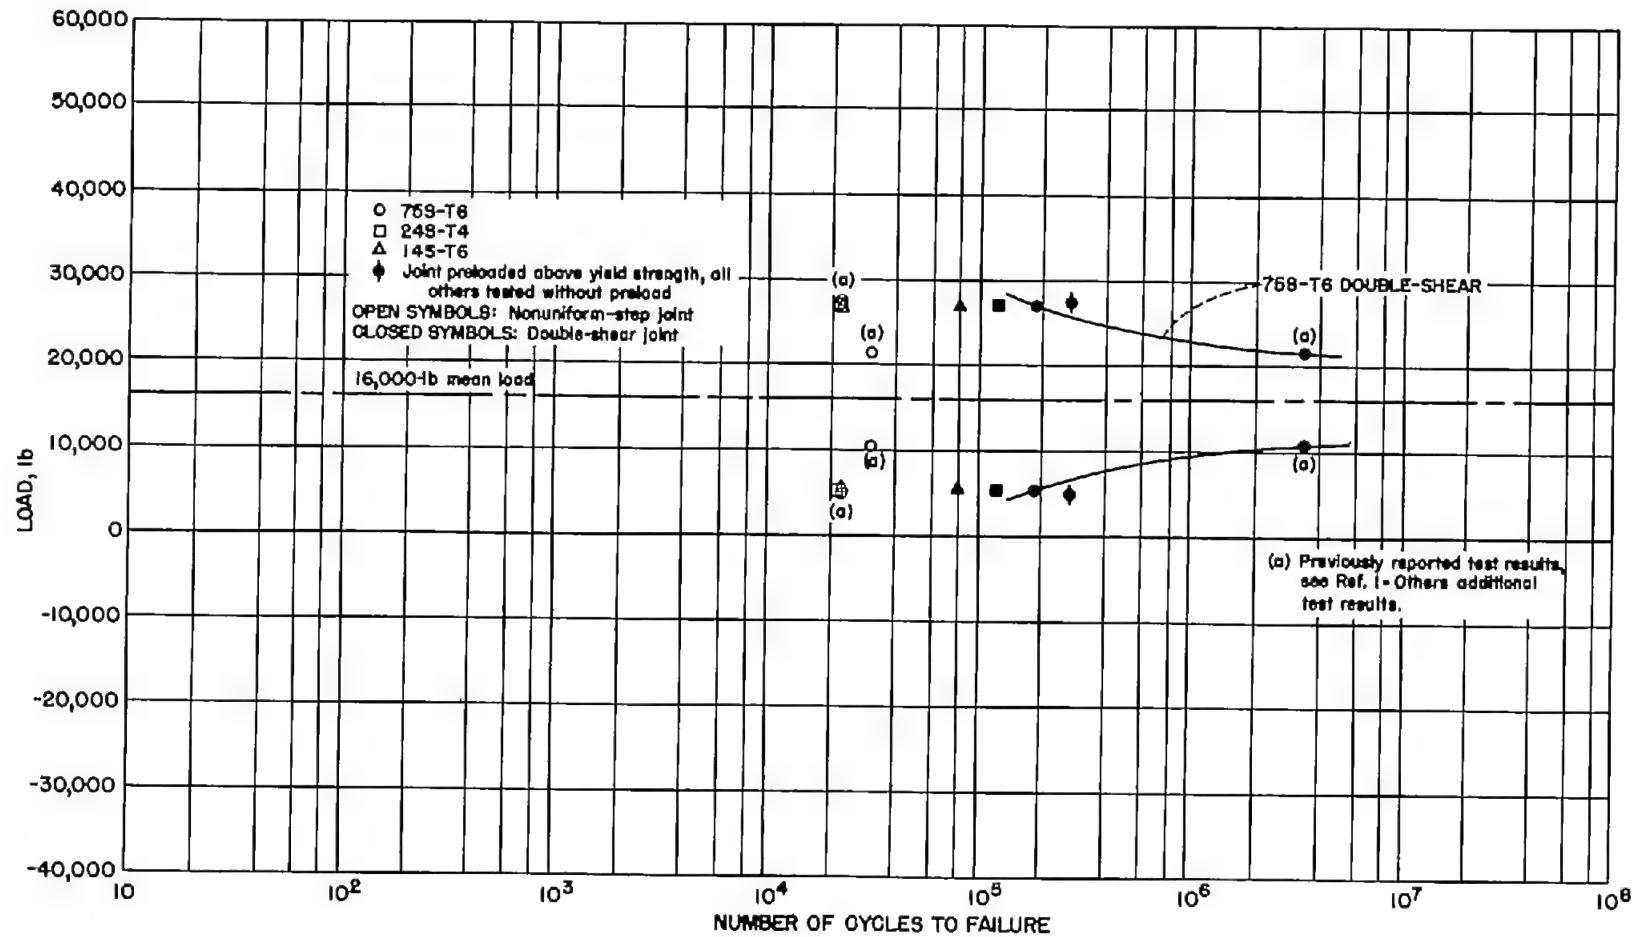
Figure 8.- Direct-stress fatigue curves for double-shear and nonuniform-step joints of 75S-T6, 24S-T4, and 14S-T6 aluminum alloys. Mean load, 16,000 pounds.

Direct-stress fatigue test results for the double-shear and nonuniform-step joints of the three aluminum alloys under consideration are plotted in figure 8 and are included in the summary of table V. For the conditions of 16,000-pound mean load $\pm 10,670$ pounds, it can be seen that there is no significant difference in the fatigue lives of the nonuniform-step joint in any of the three alloys studied. At a load of 16,000 pounds $\pm 10,670$ pounds, the fatigue life of the 75S-T6 double-shear joint exceeds the fatigue lives of the 24S-T4 and 14S-T6 double-shear joints by ratios of 1.5:1 and 2.3:1, respectively.

The direct-stress fatigue test results for the plain-scarf and double-shear aluminum-alloy joints, which had been preloaded with a static load, have been plotted in figures 8 and 11 and are included in the summary in table VI. It can be seen that the ratio of the fatigue life of the plain-scarf joint with preload to that of plain-scarf joint without preload is 5.9:1. The preloaded plain-scarf joint failed through the first row of bolt holes similar to the failure of the plain-scarf joint without preload shown in figure 15(b) (joint 2) of reference 1. The like ratio for the double-shear joints was found to be 1.4:1. As shown in figure 15, the preloaded double-shear joint failed in one of

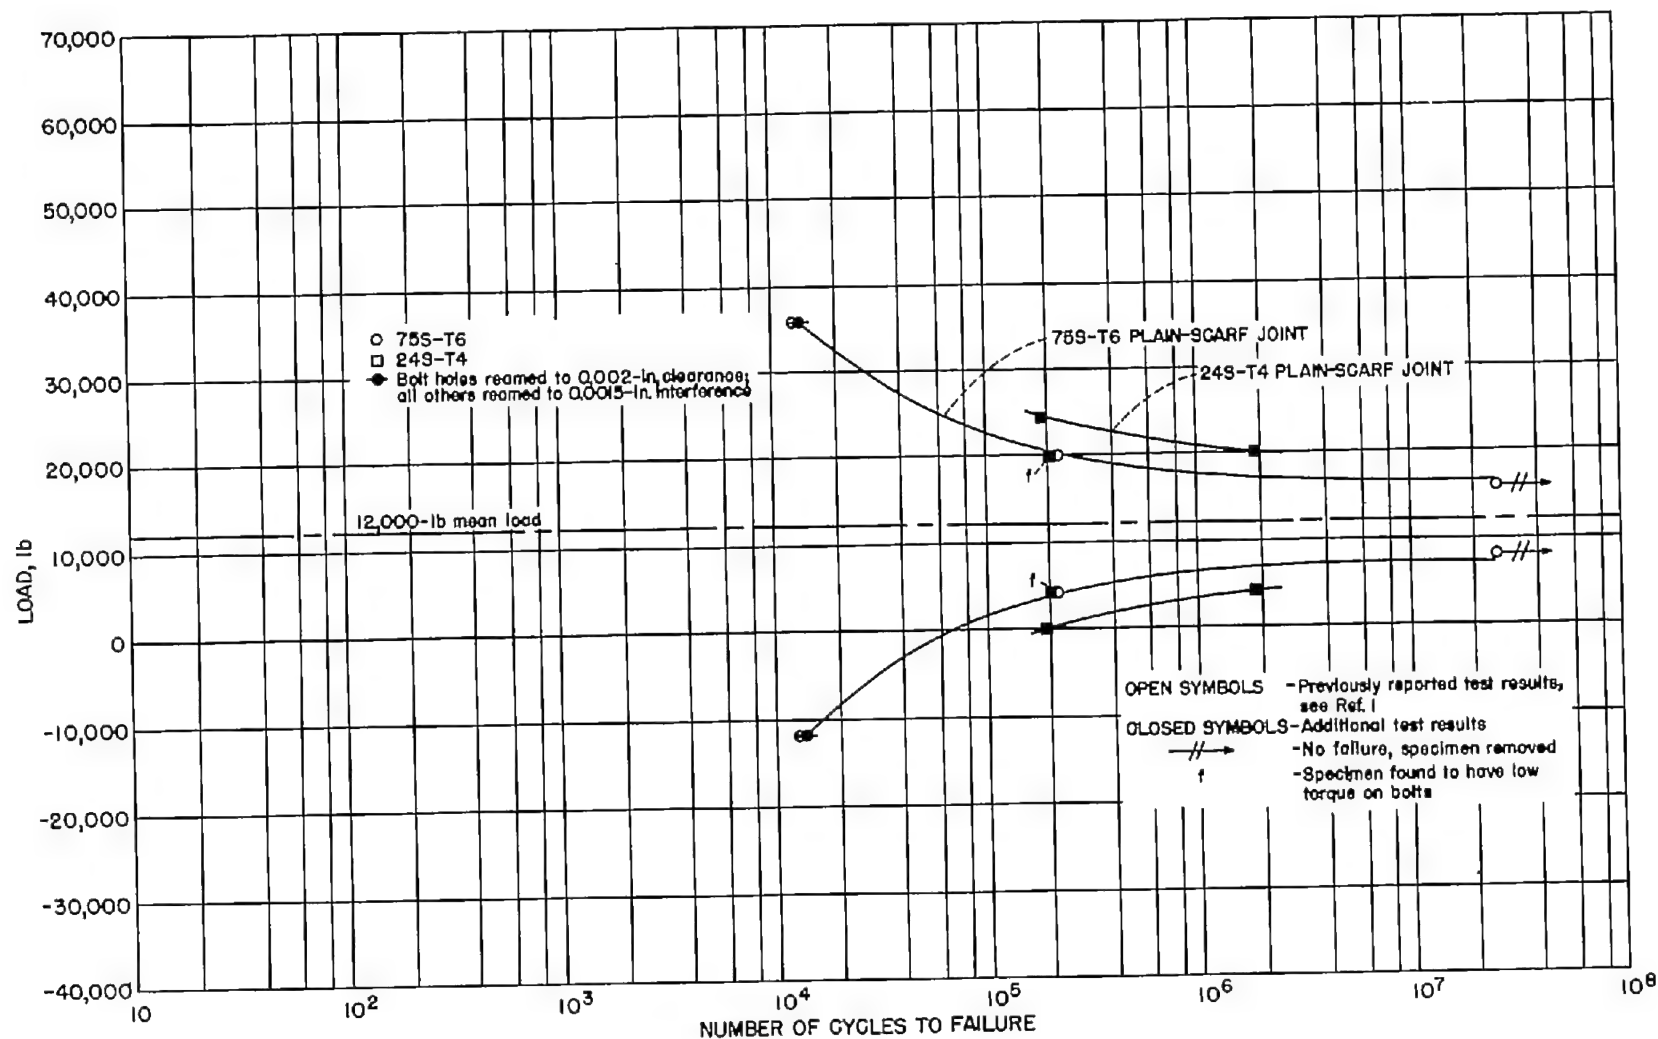
Figure 9.- Direct-stress fatigue curves for plain-scarf joints of 75S-T6 and 24S-T4 aluminum alloy. Mean load, 12,000 pounds.

The summary of results of direct-stress fatigue tests for the plain-scarf joints of 75S-T6, 24S-T4, and 14S-T6 at a mean load of 16,000 pounds and various variable loads, given in table X of reference 1, is extended in table V and figure 9 to include similar comparisons of 75S-T6 and 24S-T4 plain-scarf joints tested with a 12,000-pound mean load and various variable loads. It can be seen that the 24S-T4 plain-scarf joint gives consistently greater fatigue life than the 75S-T6 joint with the ratios of fatigue lives ranging from 1.4:1 to 18.5:1 for the mean loads and stress ratios used in these tests. For like stress ratios the fatigue-life ratios are larger in favor of 24S-T4 at the 12,000-pound mean load than at the 16,000-pound mean load.

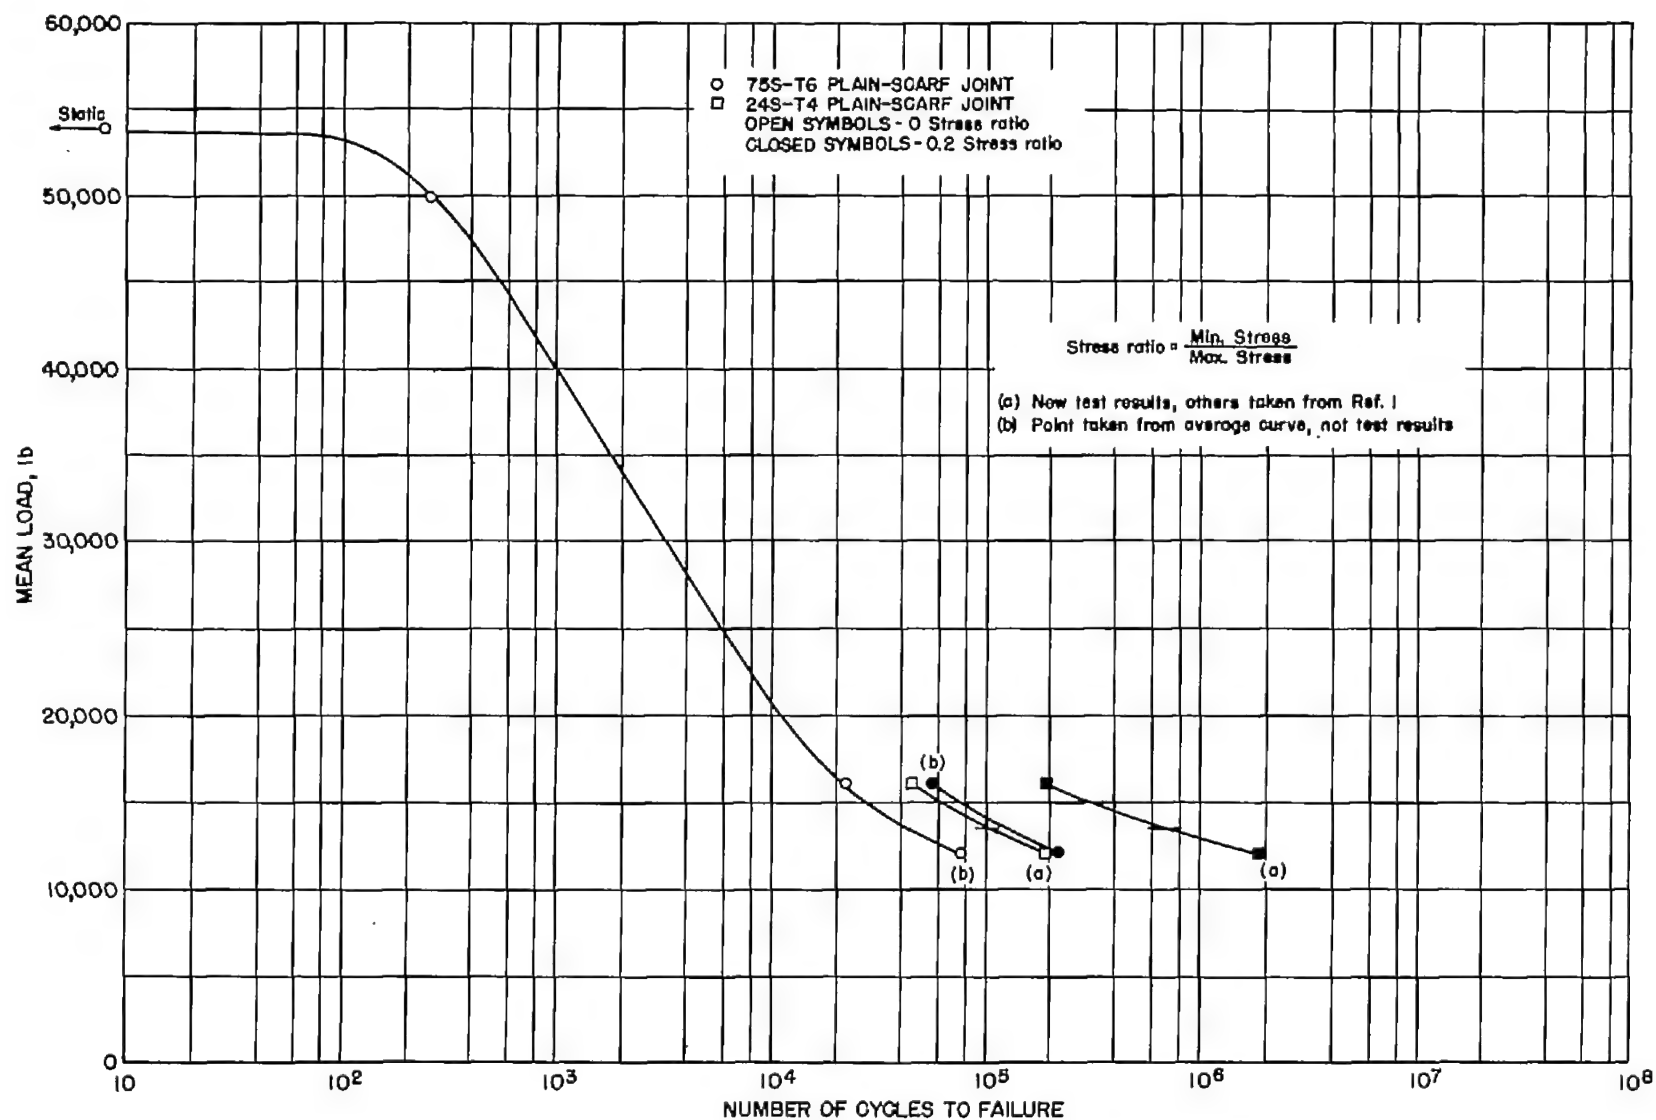
Figure 10.- Direct-stress fatigue curves for plain-scarf joints of 75S-T6 and 24S-T4 aluminum alloy. Mean load versus number of cycles to failure.

The direct-stress fatigue test results for the 75S-T6 and 24S-T4 aluminum-alloy plain-scarf joints at 0 and 0.2 stress ratios have been replotted in figure 10. In order to take care of differences in the static properties of the 75S-T6 and 24S-T4, the fatigue results for the 75S-T6 and 24S-T4 joints should be compared at lower loading conditions for the 24S-T4 joint than for the 75S-T6 joint, that is, on the basis of mean loads of 13,600 pounds and 16,000 pounds, respectively, which are proportional to the ultimate static strengths of the joints. Thus it can be seen in figure 10 that at a mean load of 13,600 pounds the 24S-T4 plain-scarf joint would be expected to fail at 100,000 and 680,000 cycles for the 0 and 0.2 stress ratios, respectively. Included in table V are comparisons of these results with the results for the 75S-T6 plain-scarf joints at the higher mean load of 16,000 pounds and at like stress ratios. The ratio of fatigue lives for the 24S-T4 joint to that of the 75S-T6 joint, when the load on the 24S-T4 joint is adjusted to take account of differences in the static strengths of the joints, is 4.6:1 and 12.4:1 for the 0 and 0.2 stress ratios, respectively. Had the loading on the 24S-T4 joint been adjusted on the basis of the ratio of the ultimate tensile strengths of the materials the mean load would be 14,600 pounds and the ratios of the fatigue life of the 24S-T4 joint to the fatigue life of the 75S-T6 joint would have been 3.2:1 and 6.7:1 for stress ratios of 0 and 0.2, respectively. Further, had the adjustment been made on the basis of the applicable guaranteed minimum values given in reference 2, the adjusted load on the 24S-T4 would have been 13,000 pounds and ratios of fatigue lives of the 24S-T4 to the 75S-T6 joints would have been 6.0:1 and 16.6:1. On the other

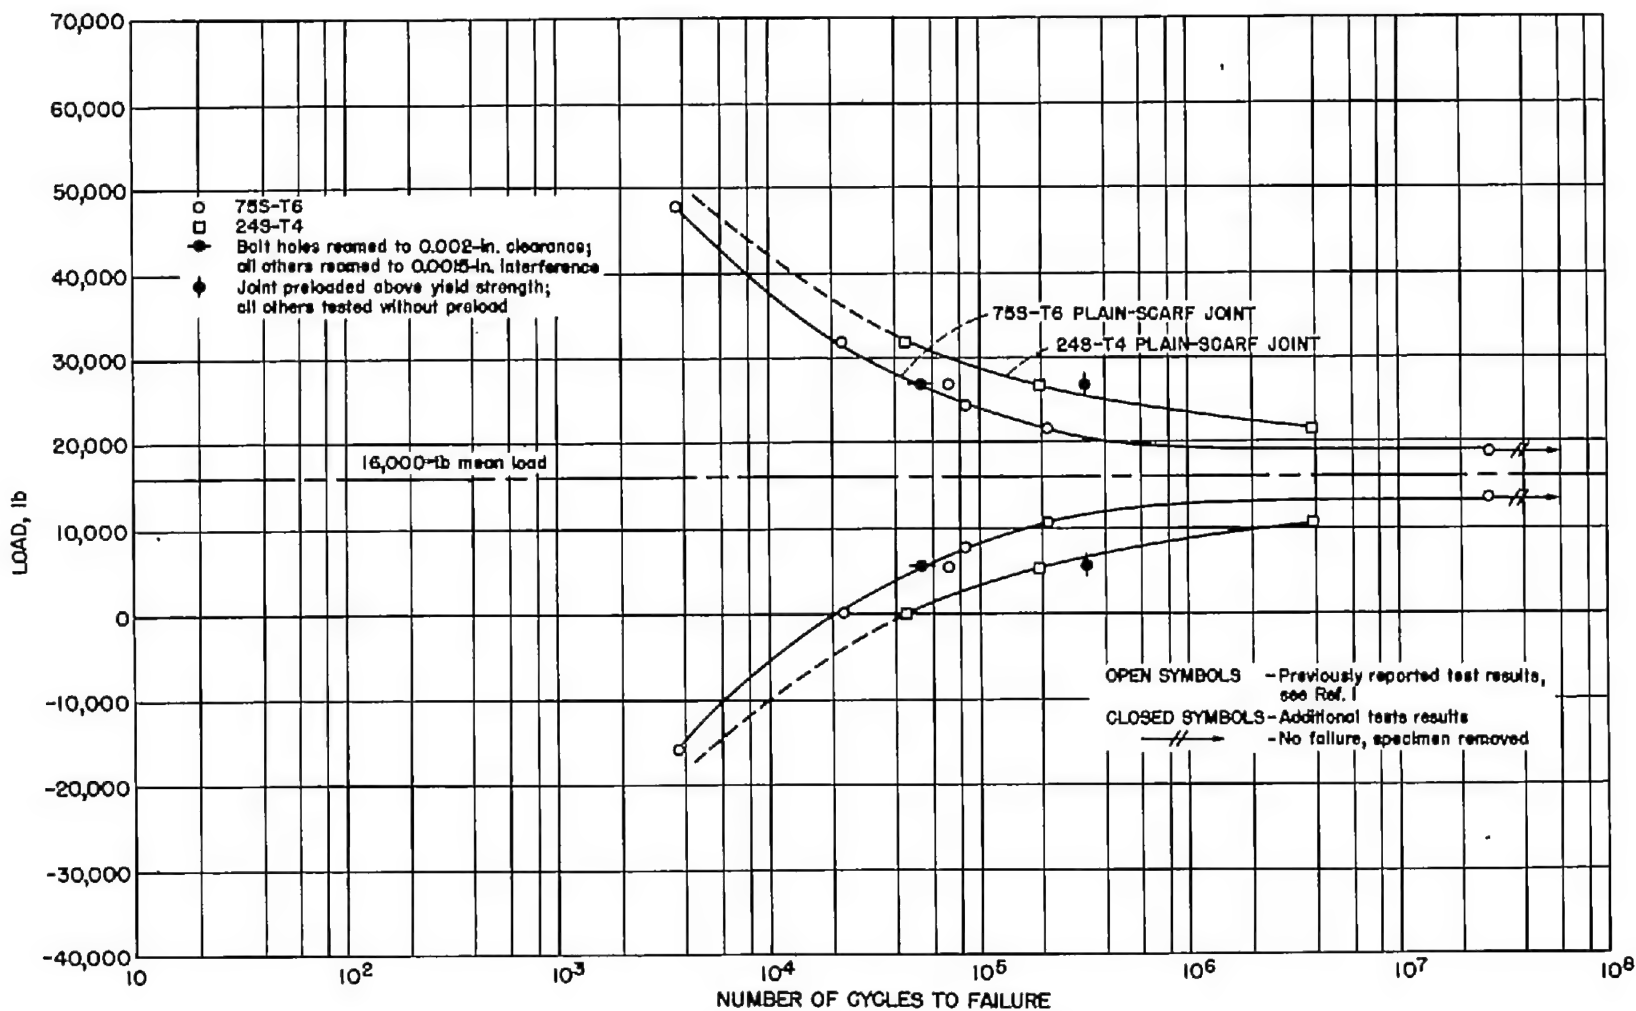
Figure 11.- Direct-stress fatigue curves for plain-scarf joints of 75S-T6 and 24S-T4 aluminum alloy. Mean load, 16,000 pounds.

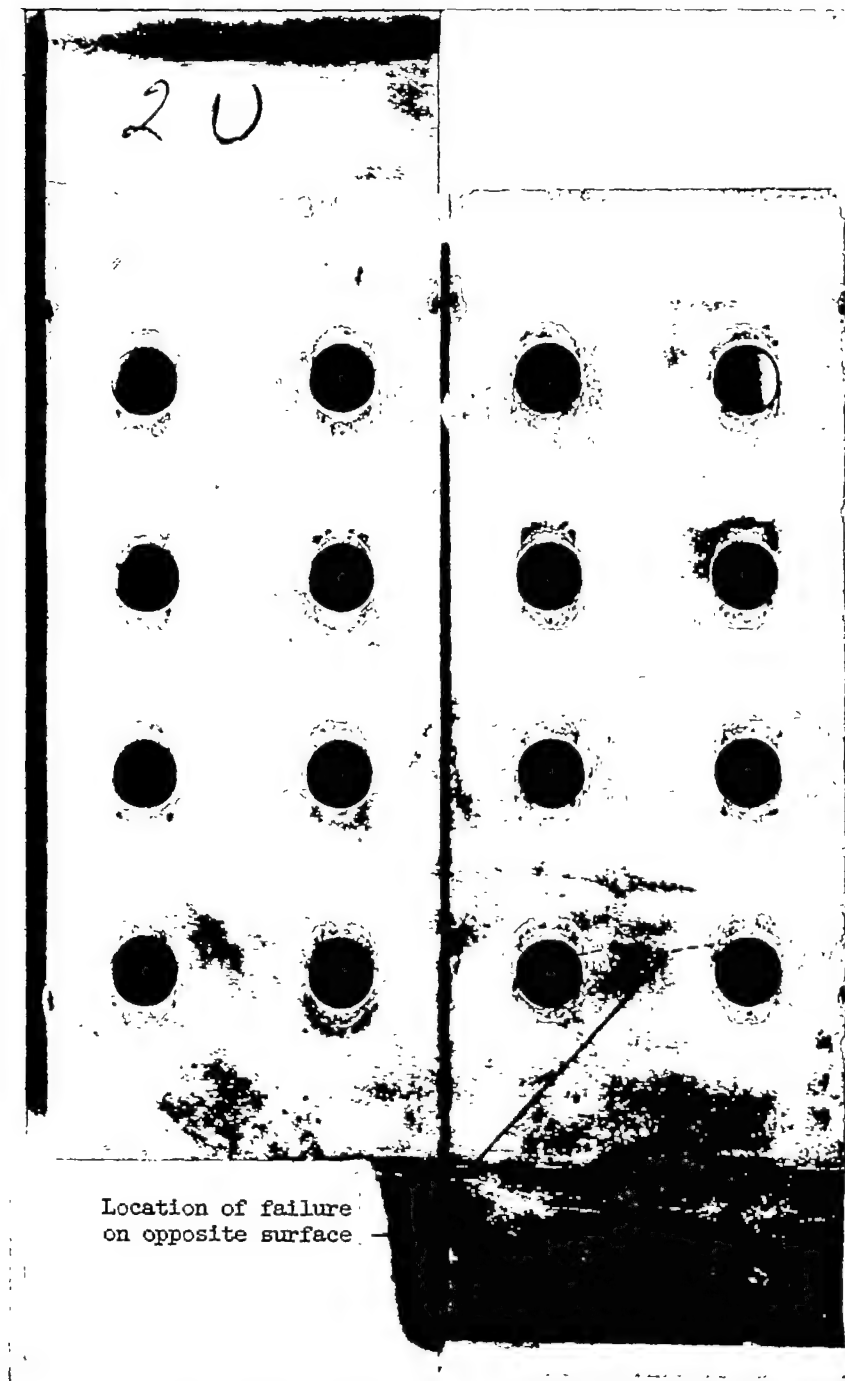
Figure 13.- Plastic deformation at bolt holes of faying surfaces of plain-scarf joint which had been loaded to high static loading previous to fatigue test. Photographed after fatigue test. (For views of failure on opposite surface see fig. 14.)

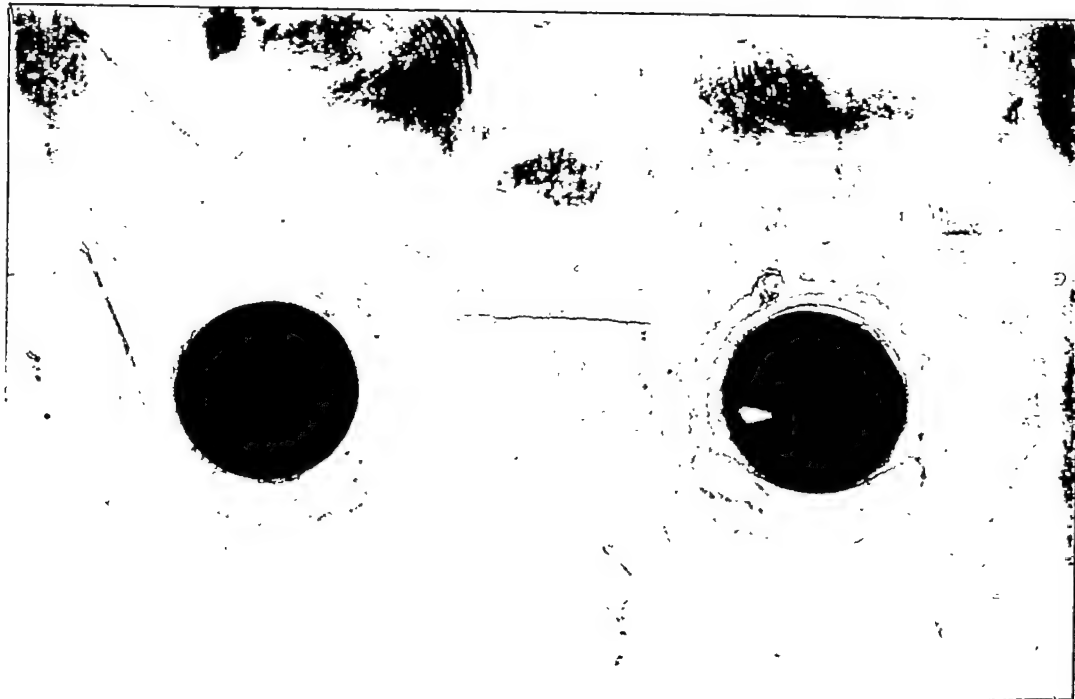
Figure 14.- Fatigue failure of plain-scarf joint which has been loaded to high static loading previous to fatigue test. (For location of bolt holes see fig. 13.)

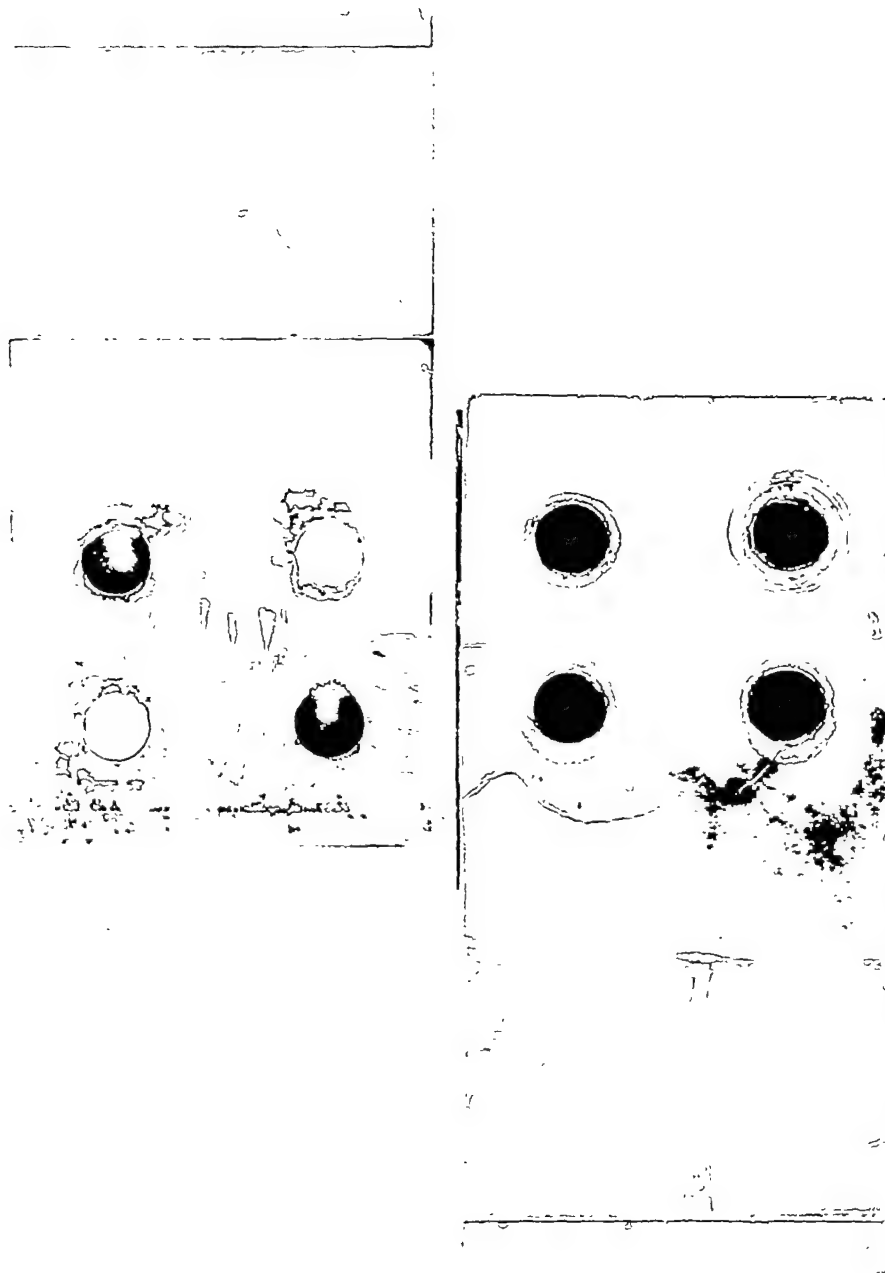
L-83695
Figure 15.- Fatigue failure in double-shear joint which had been loaded to high static loading previous to fatigue test.

the outside members in a pattern quite unlike that of the corresponding joint without preload shown in figure 15(b) (joint 9B) of reference 1. Figure 16 shows the fractured surface of the preloaded specimen. Metallographic examination indicated that the fracture originated in a fretted area on the faying surface. No sign of additional fractures was evident in the tongue of this specimen. Unless the galling caused some reduction in life of this specimen, it would appear that the location of the critical section in the double-shear joint was changed by the preload imposed with little gain in fatigue life of the joint. It has been said that preloading to 67 percent of ultimate strength increases the fatigue life from two to tenfold. The result of the test on the preloaded plain-scarf joint is in agreement with such a statement. The National Bureau of Standards has reported results of fatigue tests on sheet with static preload (ref. 4) which show beneficial as well as detrimental effects of preloading on fatigue life. It would appear from the two tests made on bolted joints that preloading may or may not have significant beneficial effects on the fatigue life of a joint.

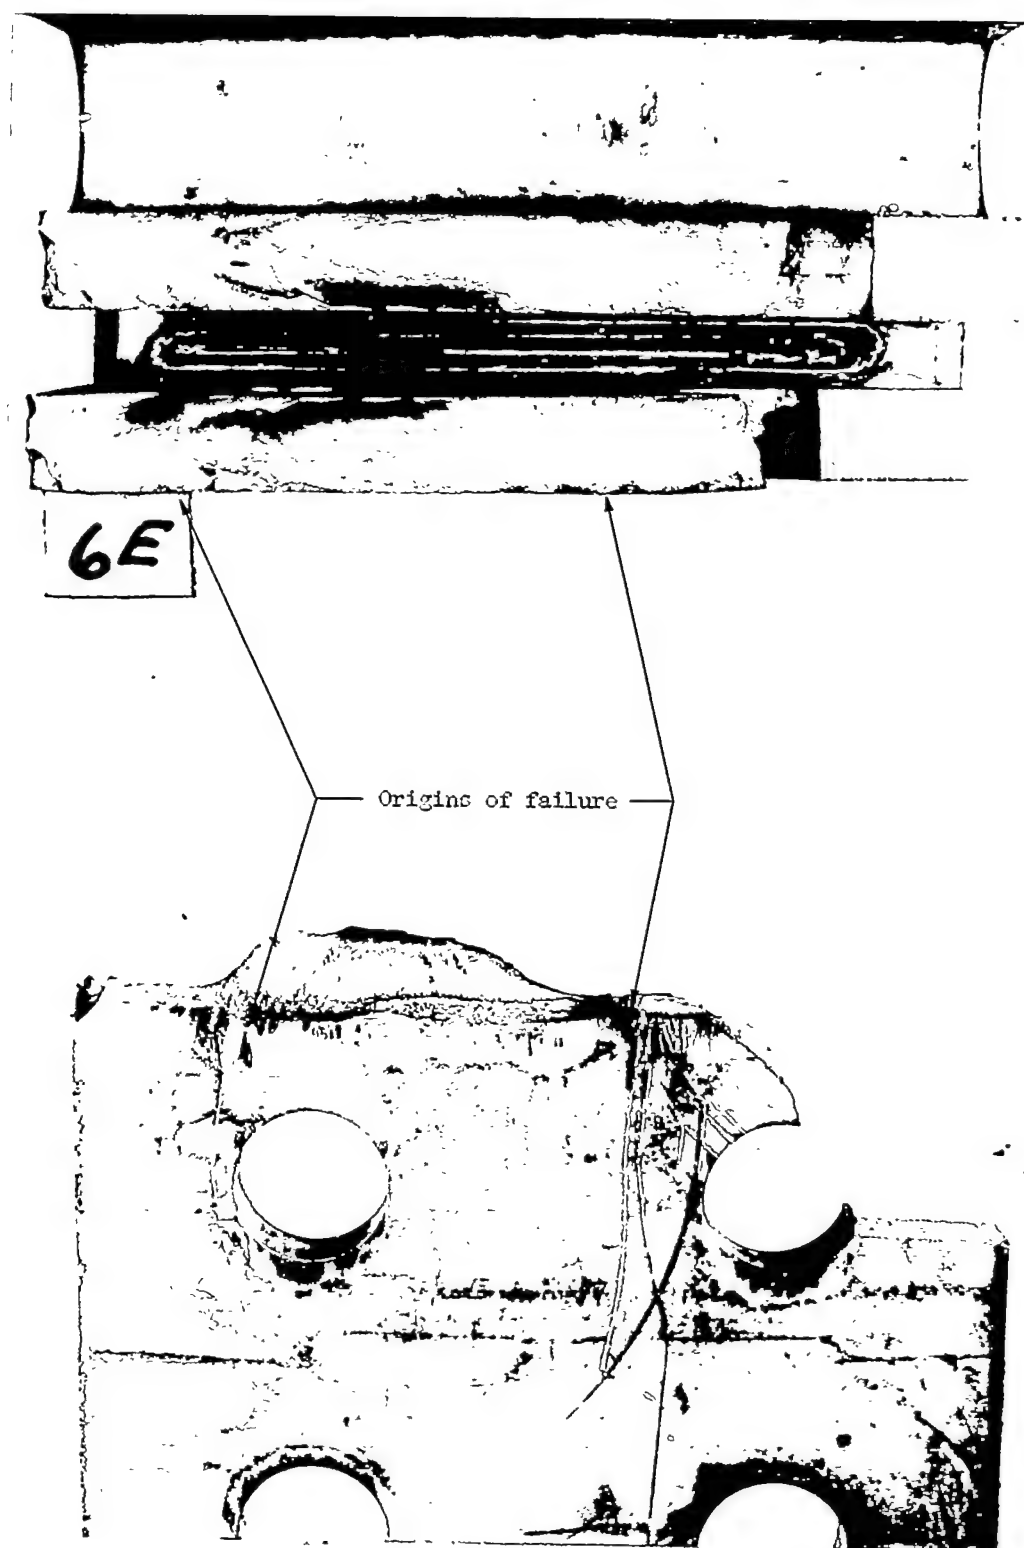
Figure 16.- Failure of double-shear joint which had been loaded to high static loading previous to fatigue test.

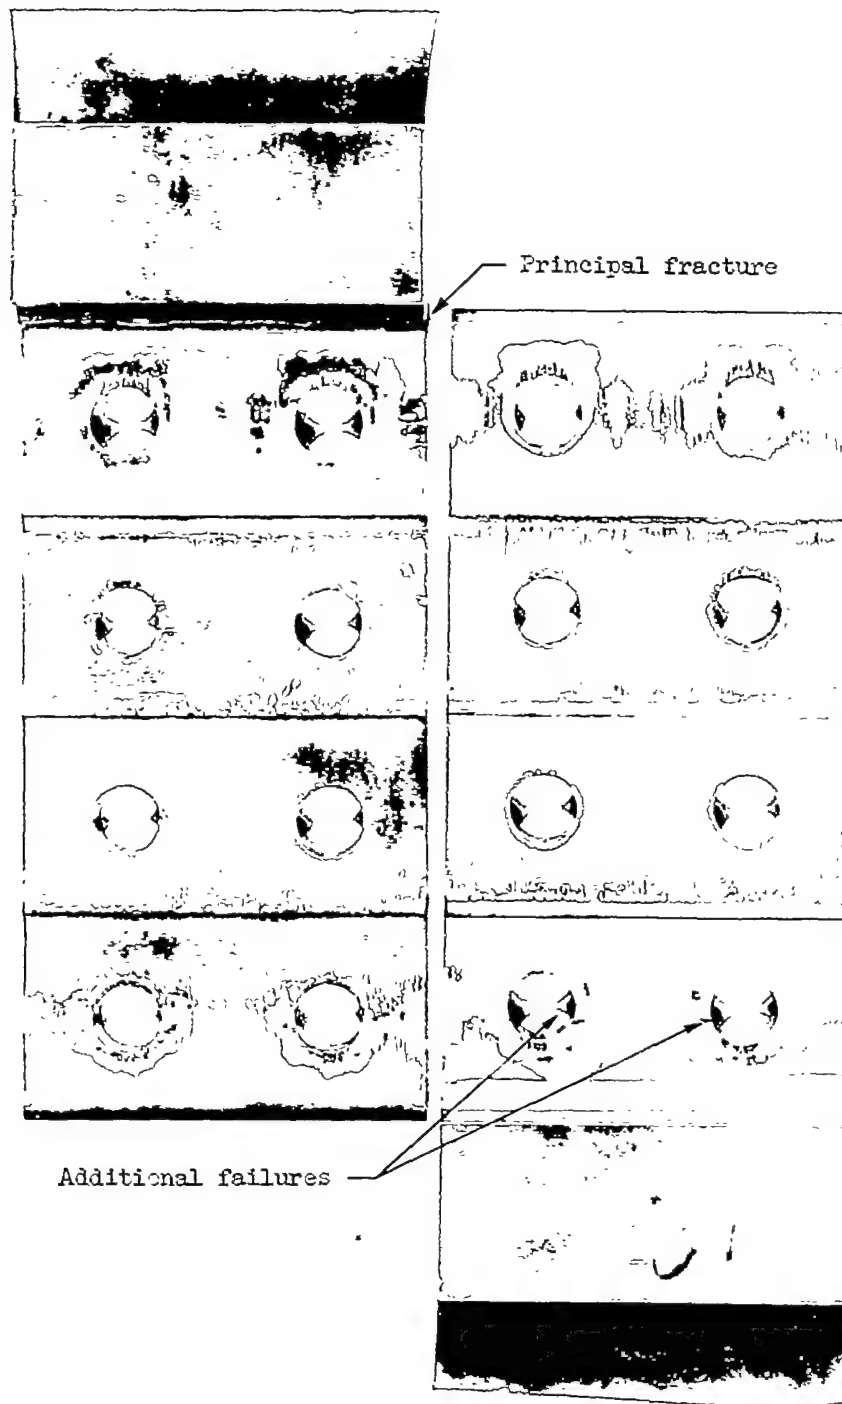
Figure 17.- Failures in 24S-T4 nonuniform-step joint. L-83697

When the bolts were removed individually from the reassembled joints, it was found exceedingly difficult to obtain evidence of the existence of some of the cracks by means of the penetrant inspection methods used. In the case of the smallest crack no evidence of its existence was found. Further, no indication was obtained of the existence of the crack, about 0.009 inch long, shown in figures 17 and 18 when the methods were used with this joint in the disassembled condition.
